Report No. CETHA-BC-CR-89352

## Task Order 2 Enhanced Preliminary Assessment

FORT DES MOINES  
DES MOINES, IOWA

December 1989

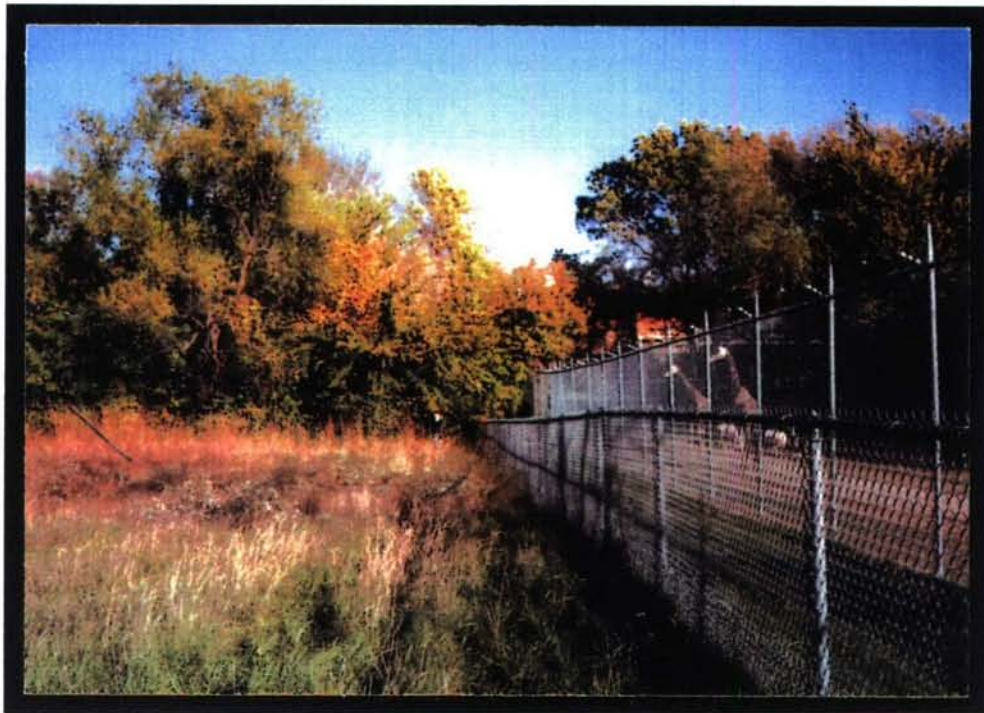
The open dump southwest of Building 135 is in a naturally occurring drainageway which extends off the property and onto the zoo south of the site. Constituents of concern conveyed by any water flowing in this drainageway during conditions of surface water runoff represent a potential hazard to visitors and occupants of the zoo.

**1. OPEN DUMPING - HEAVILY WOODED  
DRAINAGEWAY WITH OPEN DUMPING,  
ADJACENT TO THE BLANK PARK ZOO**

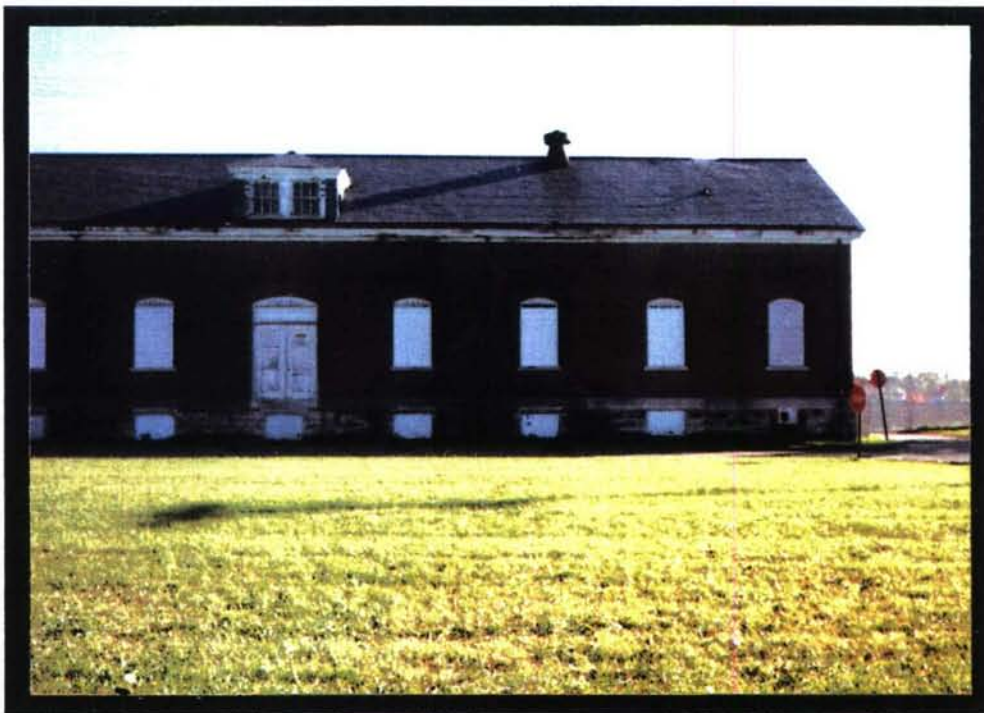
This vacant two story warehouse, which has a basement and a reported 4,032 sq ft of floor space [R-8], has been investigated previously and found to be contaminated with a variety of pesticide residues and to potentially contain PCB-contaminated oil in an abandoned elevator shaft [R-9, R-10, R-11]. The residues have been documented as accumulated dust [R-7, R-8].

The condition of the elevator shaft in Building 138 is not known and the oil level is not monitored. Leakage from this shaft probably represents the greatest potential for groundwater contamination from Building 138. However, rainfall infiltrating from contaminated vegetated areas surrounding the building could also convey contamination into the groundwater. If groundwater flow follows the ground surface topography in the vicinity of the building, it would appear to have the potential to convey groundwater contaminants in a southwesterly direction towards the Blank Park Zoo maintenance shed because there is a southwesterly trending dip in this area.

**2. BUILDING 138 - VIEWED FROM THE  
NORTH LOOKING SOUTH**

Interior dust samples should be collected and analyzed for dioxin and pesticide related metals. Wipe samples should be taken for PCB analysis from the second floor of the building where leaking transformers were stored. A liquid sample should be taken from the elevator shaft and analyzed for PCBs, pesticides, total petroleum hydrocarbons (TPH) and caloric value. Surface soil samples collected from 0 to 6 in. should be taken around the periphery of the building and analyzed for pesticides and related metals. The drainage pattern from the building and site should be investigated by collecting sediment samples in the drainage stream and receiving water body (Blank Park Zoo flamingo pond). The sediment samples should be analyzed for pesticides and priority pollutants.

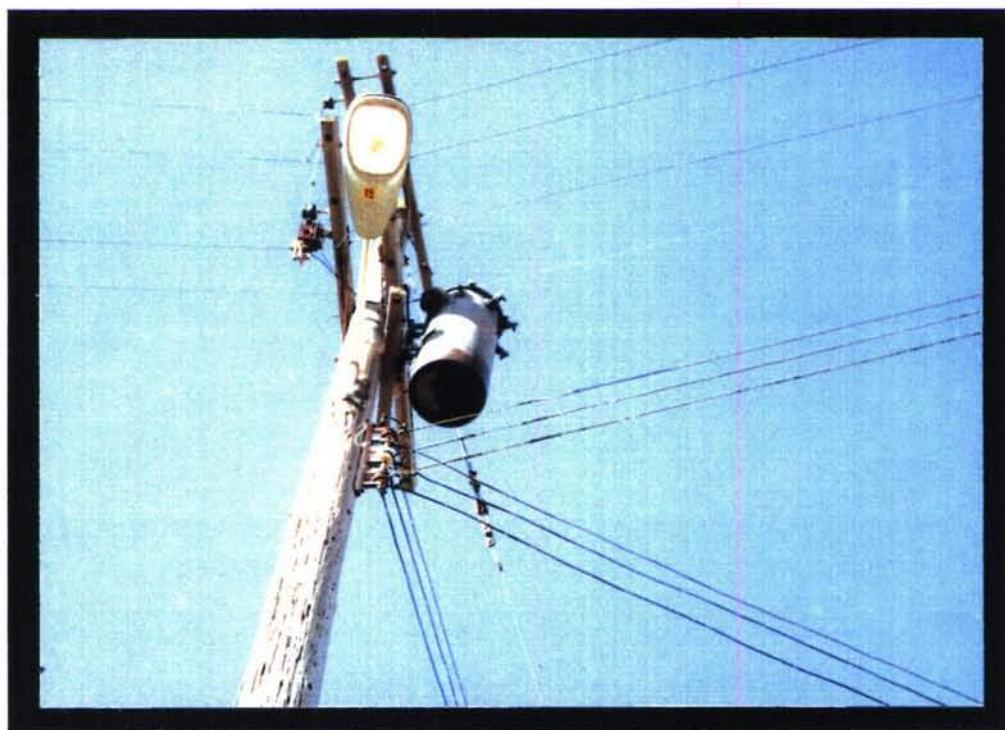
The location of each of the twenty transformers that are still mounted on utility poles is provided in Figure 3-1. Photos 3 and 4, respectively show the condition of a transformer which has failed and spilled its potentially PCB-contaminated oil on the ground and one that typifies the visible staining indicative of partial leakage from the bottom of some of the others. Photo 5 shows the deteriorating conditions of transformers still in use. Photo 6 shows the bituminous-based sealant, which reportedly used PCBs as a softening and emulsifying agent, in an expansion joint in the concrete along Rodgers Road [I-1]. It was reported that approximately 140 transformers had been stored in Building 138 until 1982 when they were removed from the property. No photograph was taken of the elevator shaft inside Building 138 during the site visit because the reported contamination precluded entry without suitable health and safety equipment.

**3. DOCUMENTED PCB LEAK AND SPILL  
FROM THIS FAILED TRANSFORMER**

The deteriorating and leaking conditions of the transformers and the discovery of PCB in a failed transformer suggest that the aging transformers should be replaced as soon as possible. In lieu of removing all the transformers, PCB analysis should be conducted in order to establish a priority replacement order based on the presence or absence of PCBs and the structural integrity of the transformer housing. The site of the confirmed PCB spill from a transformer should be tested by collecting a soil sample at a depth of between 0 to 6 in. and analyzing it for PCBs to confirm the extent of the cleanup. Wipe samples should be taken in Building 309 in the area where transformers are stored to determine whether leakage of PCBs from the storage of the transformers has occurred. A composite surface soil sample should be collected at the former transformer location west of Building 307 and analyzed for PCBs.

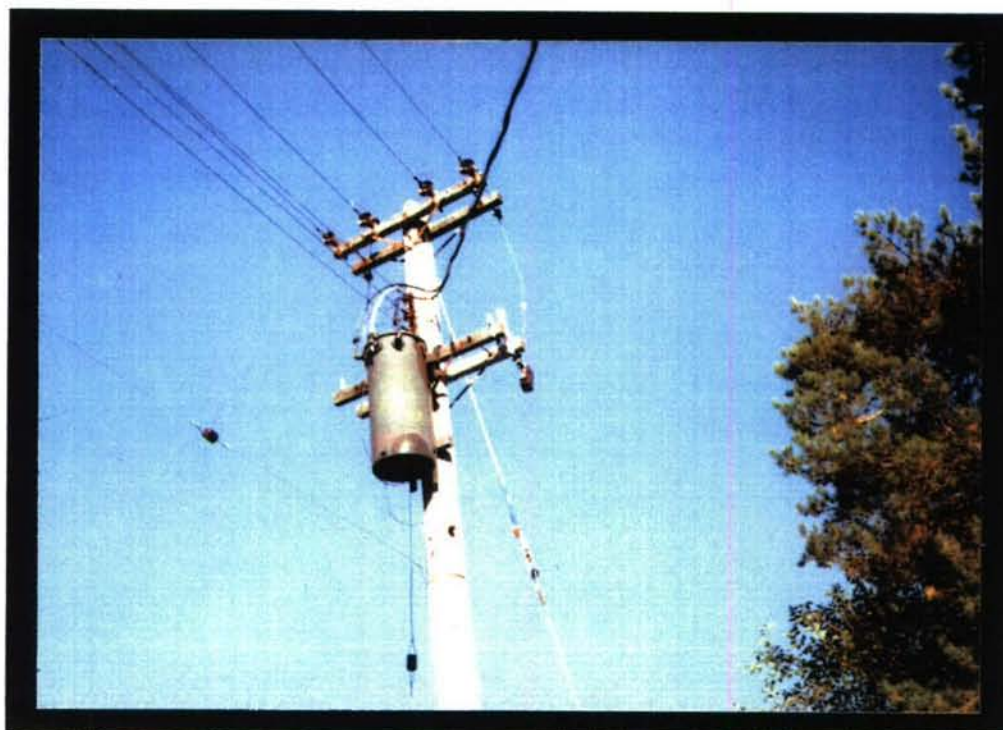
**4. LEAKING POLE TRANSFORMER LOCATED  
NEAR THE GSA BUILDING**

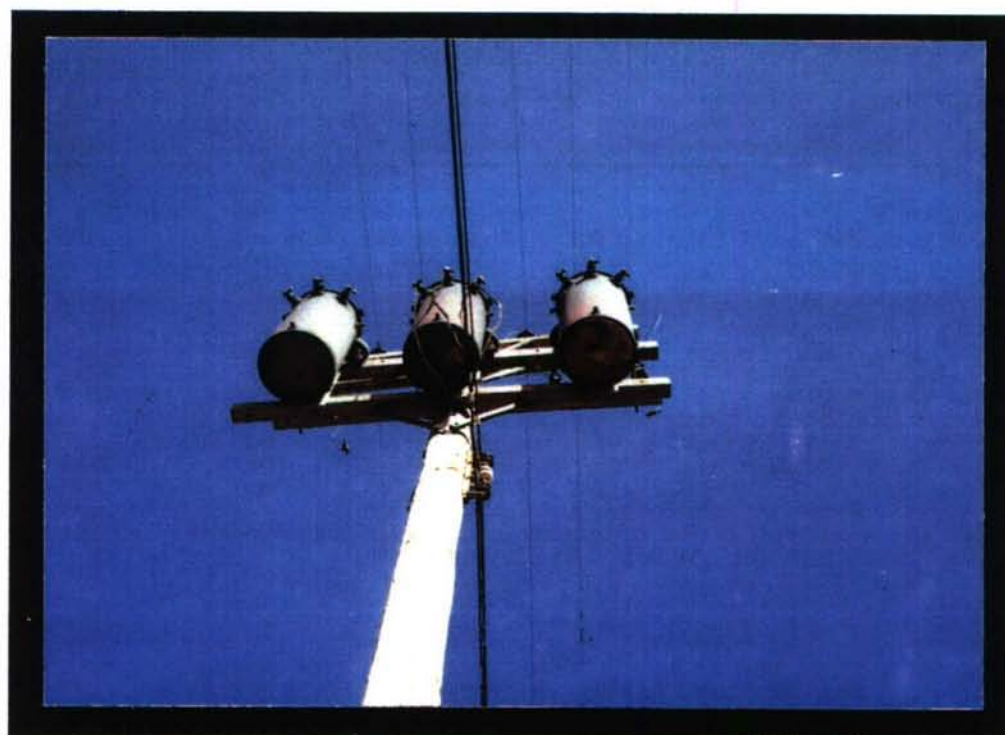
**5. RUSTING POLE TRANSFORMERS LOCATED  
BETWEEN BUILDINGS 56 AND 58**

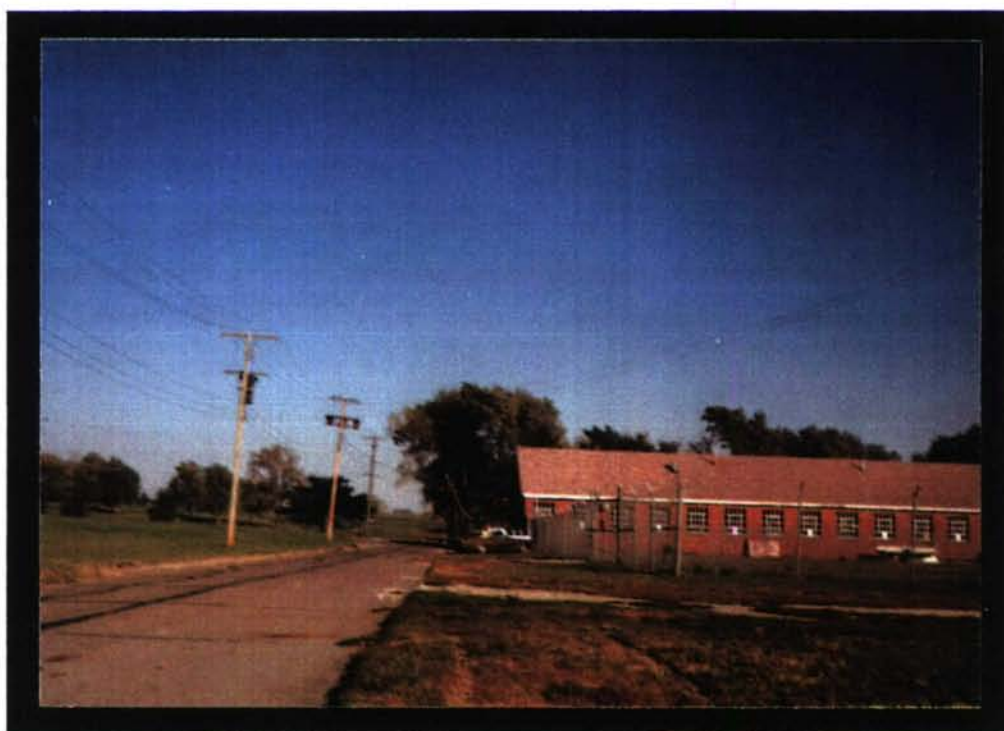
- Rodgers Road - Road expansion and crack sealant used on Rodgers Road suspected of containing PCBs.

**6. PCBs - BITUMINOUS JOINT AND CRACK  
SEALANT REPORTEDLY CONTAINING  
PCBs ALONG DARK LINES ON RODGERS ROAD**

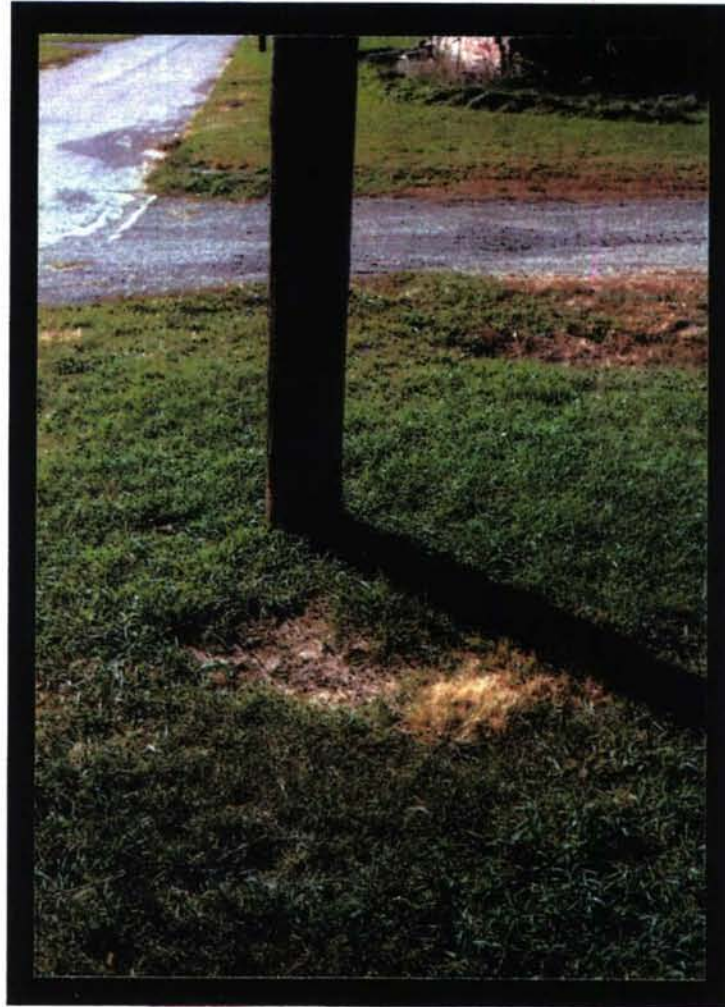
**7. STRESSED VEGETATION AT SITE OF PCB  
SPILL FROM POLE MOUNTED TRANSFORMER**

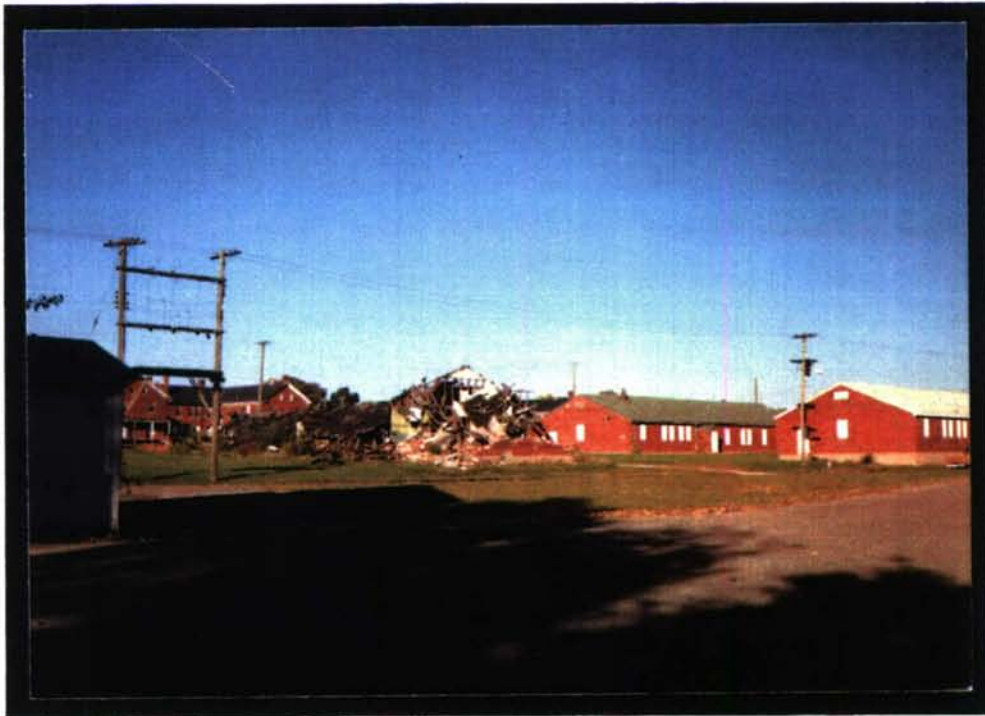
Pipeline insulation which reportedly contains asbestos is outside and exposed to the weather along a 1 to 2 in. abandoned hot water line that runs overhead for about 50 to 75 ft between Buildings 122 and 123. The suspected asbestos wrapping of the heating water tank at Building 307 is located outdoors, where it is deteriorating and exposed to the weather.

**8. COLLAPSED BUILDING 307 WITH  
ASBESTOS-WRAPPED WATER HEATER TANK**

- Immediate Action - Confirm the presence or absence of friable asbestos in the materials in Buildings 307, 122, and 123. Asbestos confirmation should be followed by immediate removal of the material in Building 307 and encapsulation or removal of the material in Buildings 122 and 123.
- Immediate Action - Repair and replace boarding material in Building 138 to secure the building. Exterior maintenance, especially to the slate roof, is necessary to control building deterioration and control contaminant migration.
- Site Investigation - All other ESOs should be further characterized through a program of sampling and analysis and other investigations.

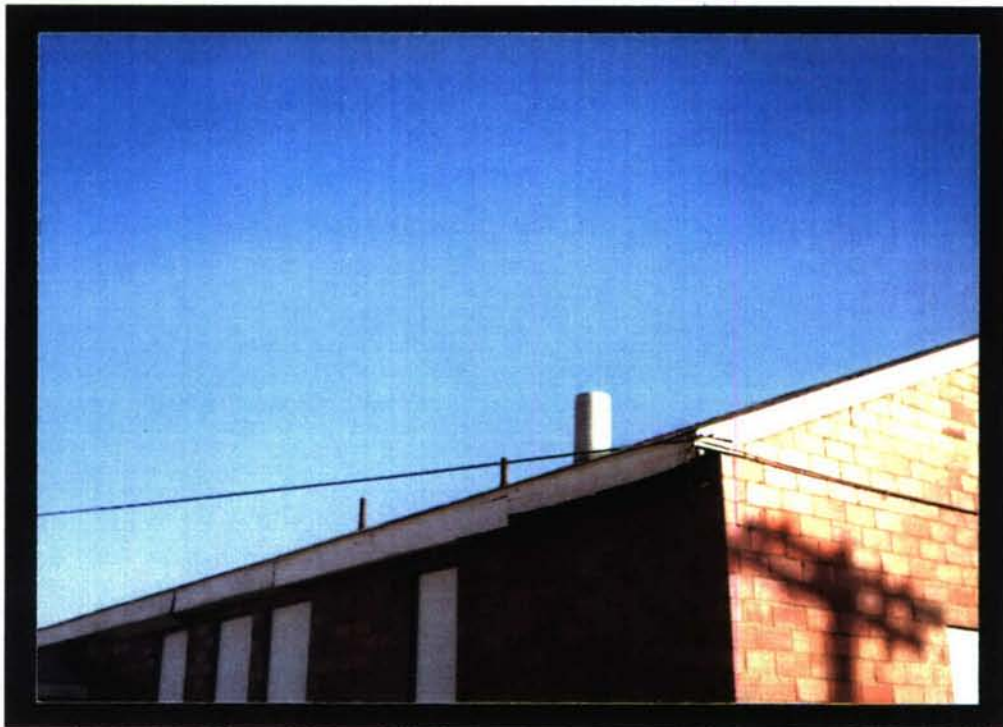
**9. REPRESENTATIVE SUSPECTED ASBESTOS CEMENT  
SEWAGE VENT PIPE (BUILDING 309)**

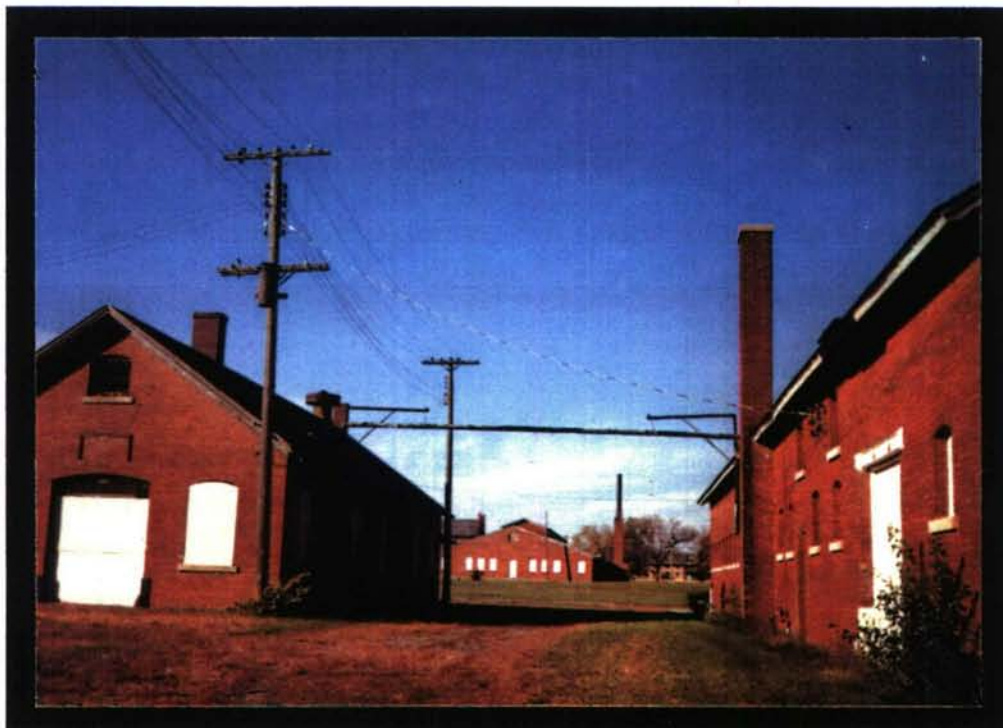
**10. SUSPECTED ASBESTOS INSULATED  
HEADER PIPE RUNNING OVERHEAD  
BETWEEN BUILDINGS 122 AND 123**

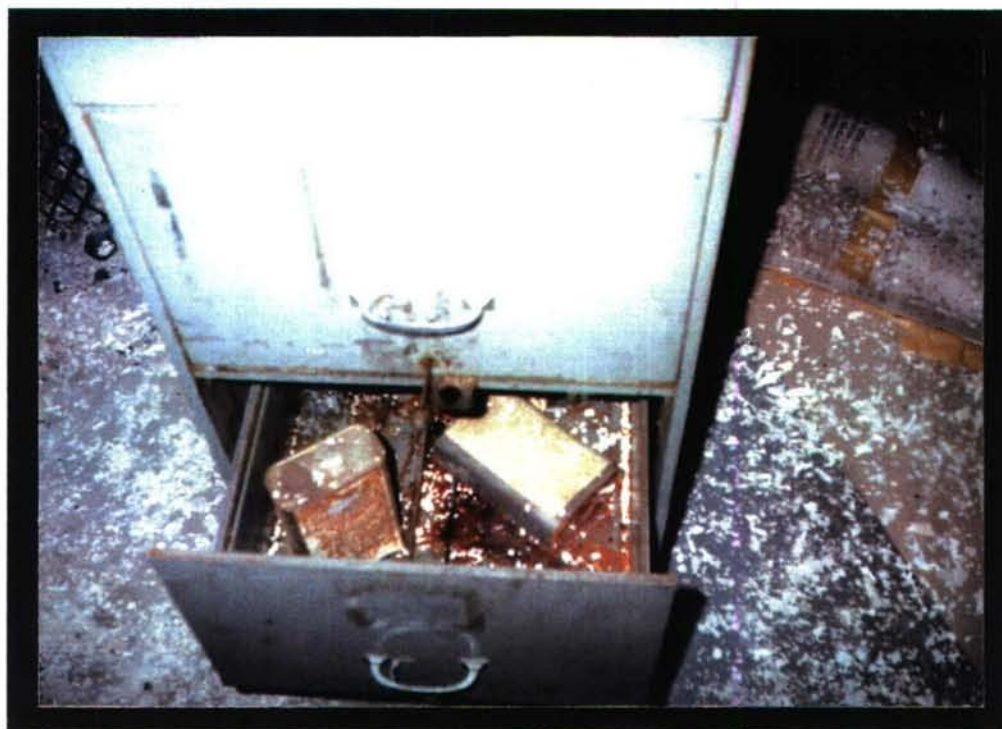
**11. CHEMICALS IN FILING CABINET IN BUILDING 55**

Wipe sampling in the basement of Building 55 is recommended due to the lack of information about the chemicals contained in the basement. Wipe samples should be analyzed for the priority pollutants. The chemicals should be discarded in an appropriate manner.

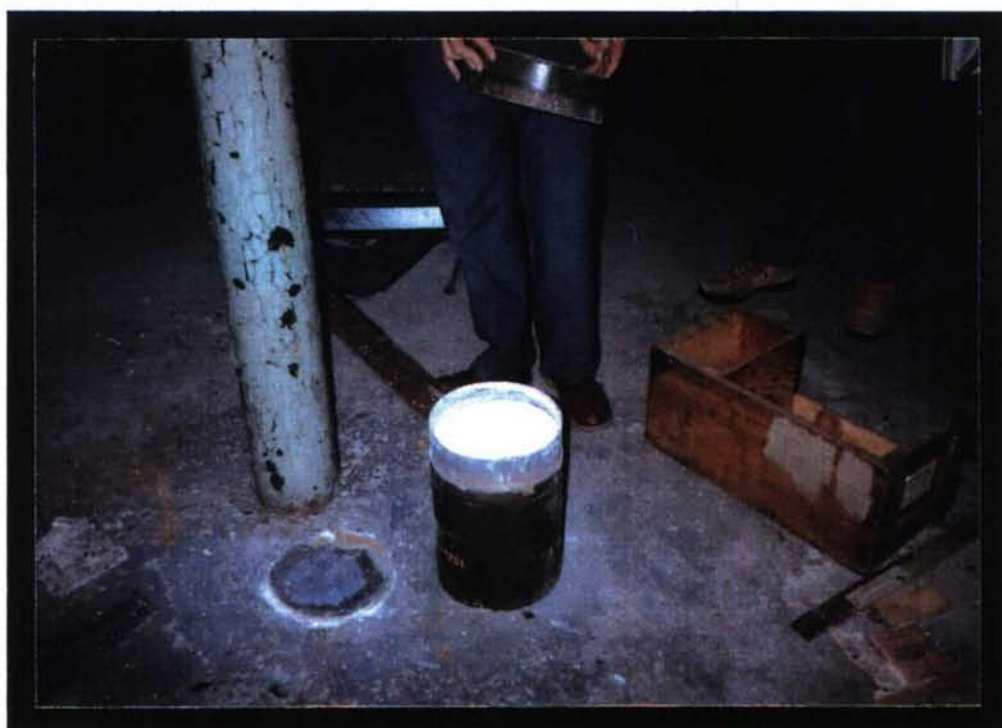
**12. UNKNOWN CHEMICALS LOCATED IN THE  
BASEMENT OF BUILDING 55**
